For the Property at:
111 SAAMPLE PARK LANE
BRENTWOOD, TN 37027

Prepared for: JANE AND RICHARD CLIENTS
Inspection Date: Thursday, February 17, 2011
Prepared by: Jerry Spiva

RE: Report No. 1110, v.3
111 Saample Park Lane
Brentwood, TN
37027

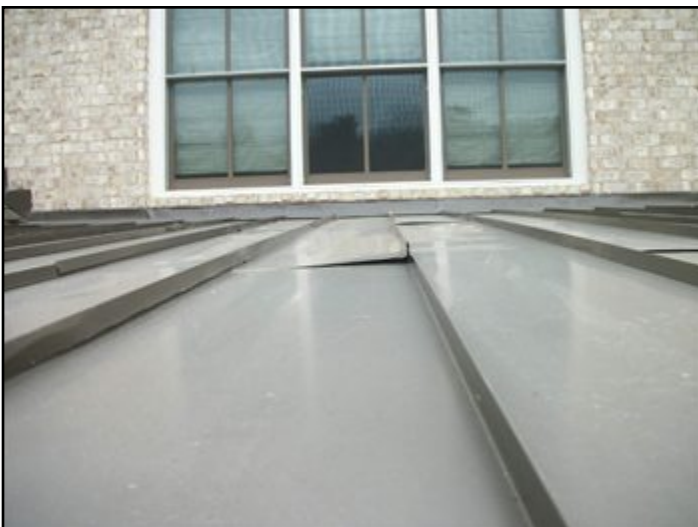
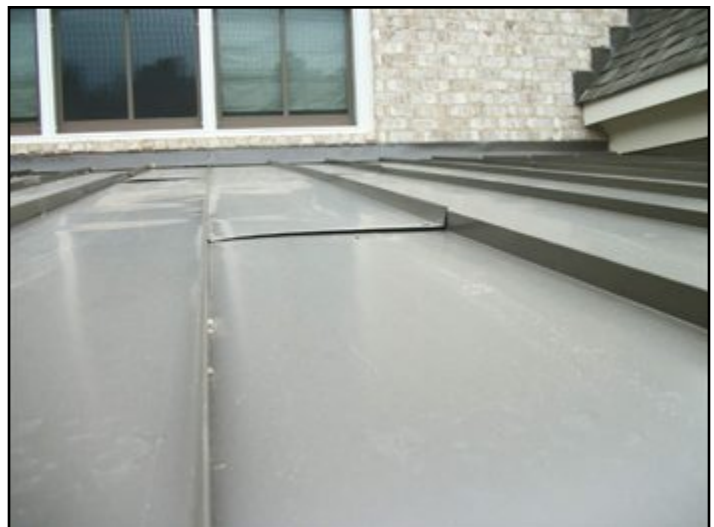
Condition: • [Missing, loose or broken pieces](#)

Implication(s): Chance of water damage to contents, finishes and/or structure

1. Lifted panel

2. Lifted panel

Task: Repair

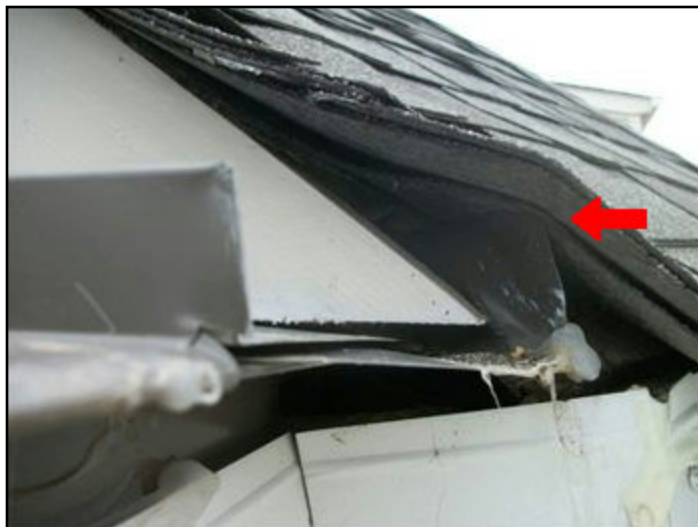
Condition: • The flashing is lifting and damaging a shingle at the left corner of the breakfast room.

Implication(s): Damaged shingle-chance of leakage

3. Flashing is tearing a shingle

Task: Repair

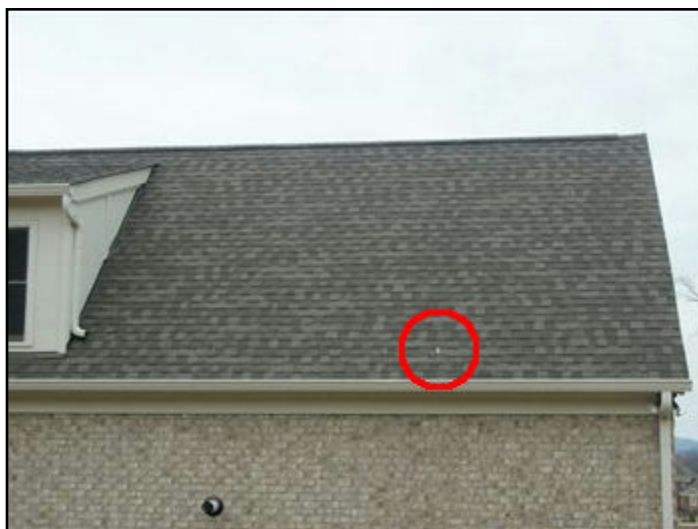
Condition: • Debris under a shingle on the rear slope of the main garage should be removed.

4. Debris under a shingle

Task: Repair

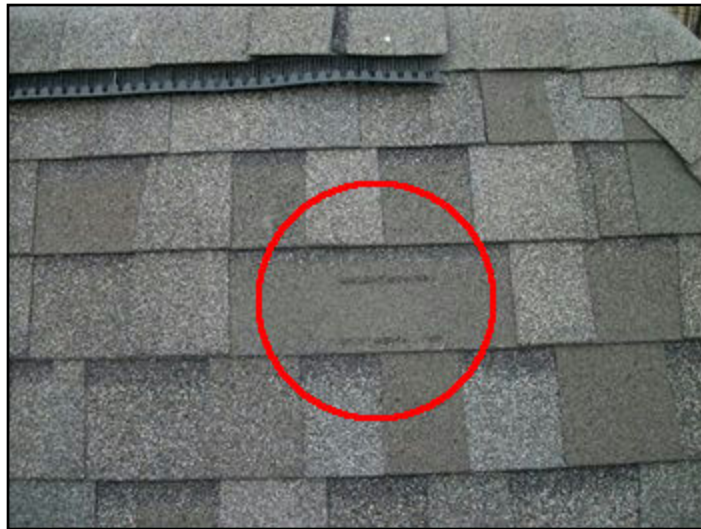
Condition: • Minor shingle damage noted.

One of the laminated tabs is missing.

5. Laminated tab is missing

Task: Replace

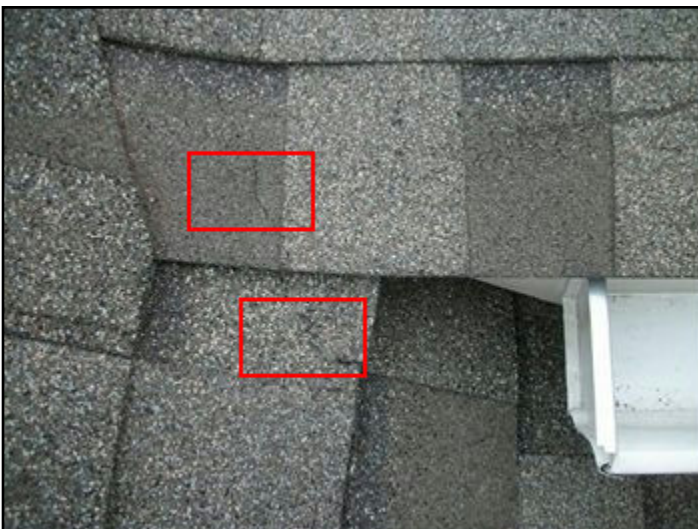
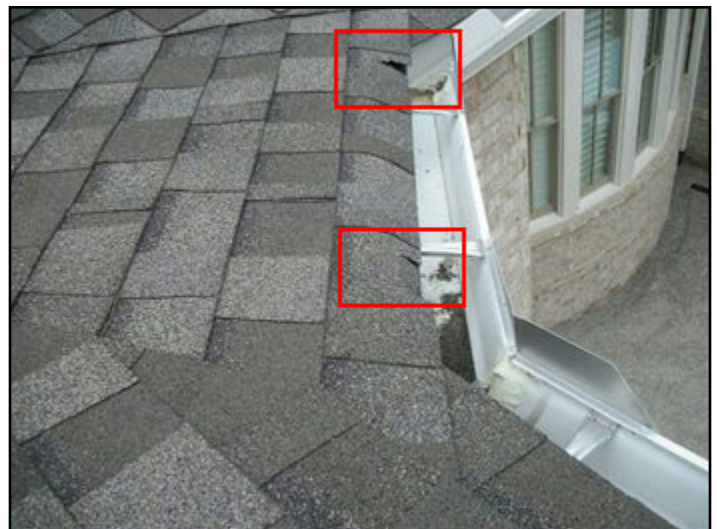
Condition: • Minor shingle damage noted.

Implication(s): Chance of leakage

6. Minor shingle damage

7. Minor shingle damage

Task: Replace

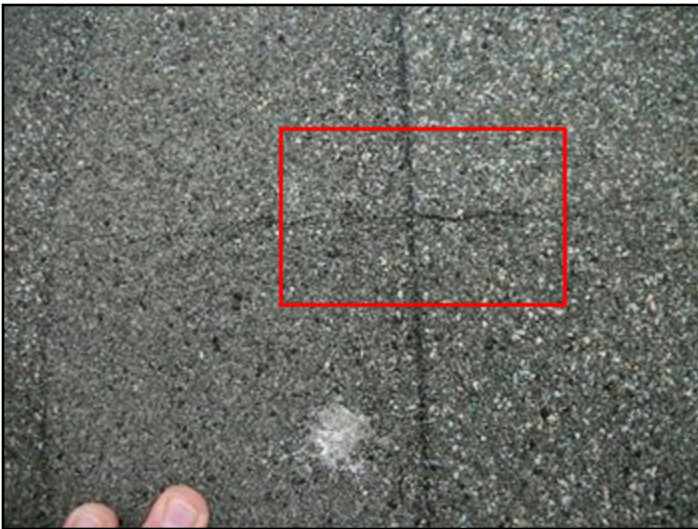
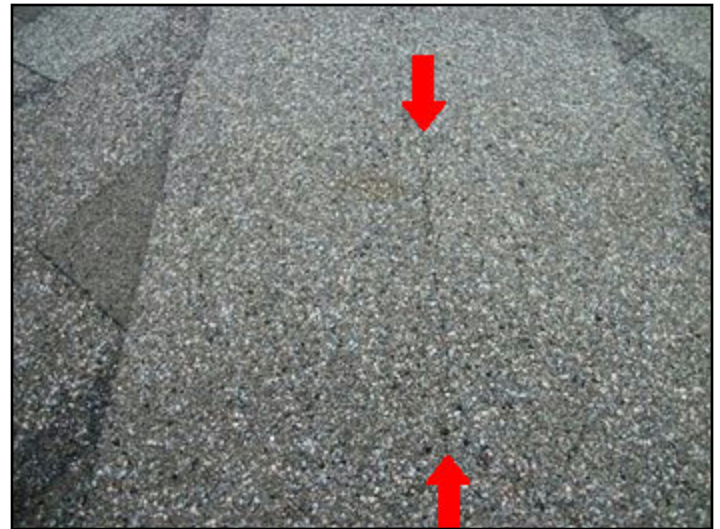
Condition: • [Cracked](#)

Several ridge shingles are cracking.

Implication(s): Chance of water damage to contents, finishes and/or structure

Task: Repair or replace

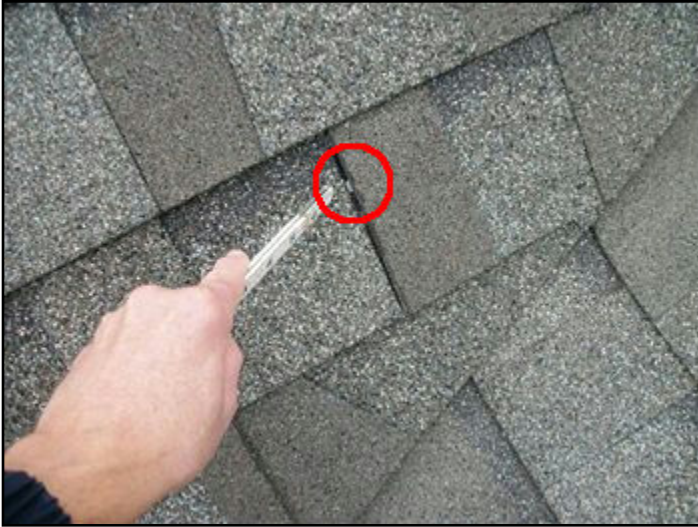
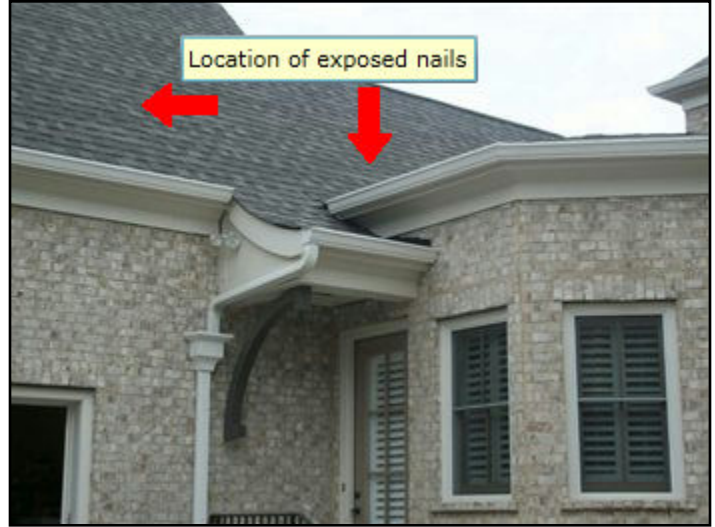
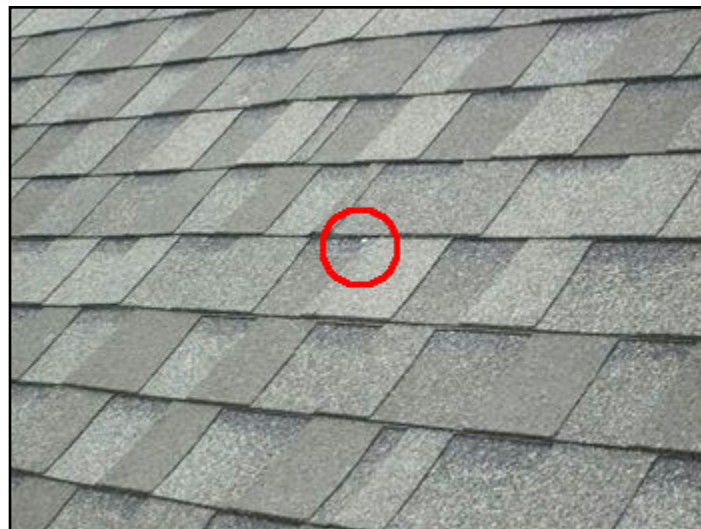
Condition: • [Exposed fasteners](#)

Two exposed roofing nails are present on the roof. Nails such as these are hard to find and are easily missed. Recommend having a roofer examine the roof for exposed nails and repair or replace as necessary.

Implication(s): Chance of water damage to contents, finishes and/or structure

10. Exposed fastener-valley near side porch

12. Exposed fastener @ garage

Task: Repair

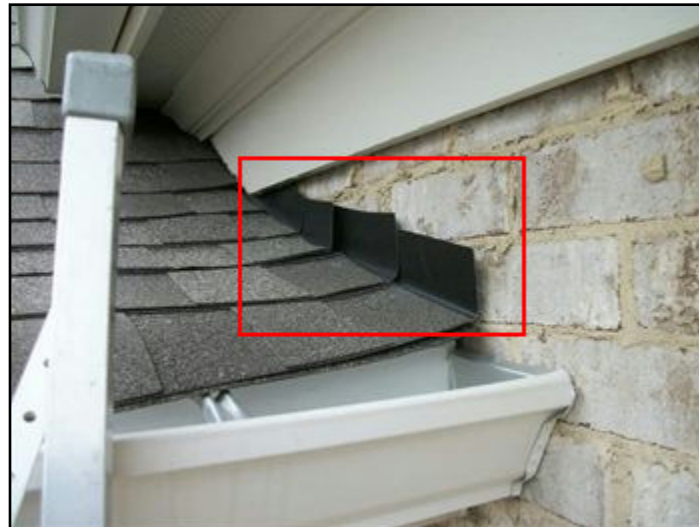
Condition: • [No step or counter flashings](#)

Implication(s): Chance of water damage to contents, finishes and/or structure

13. No counter flashing

Task: Repair

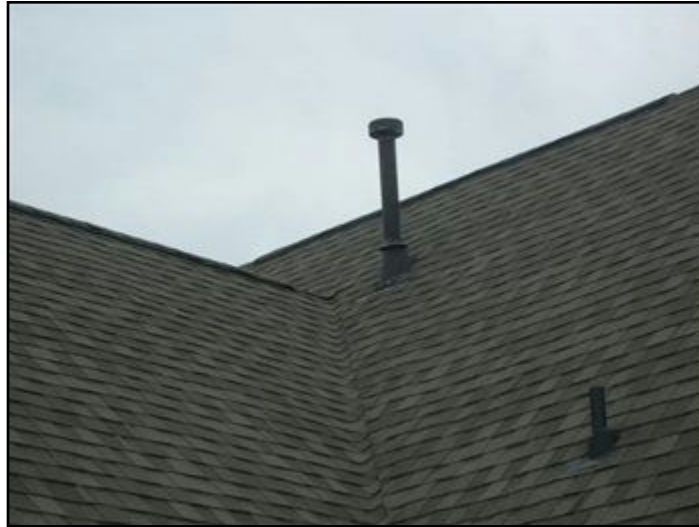
14. *Peeling paint on flue*

Task: Repaint

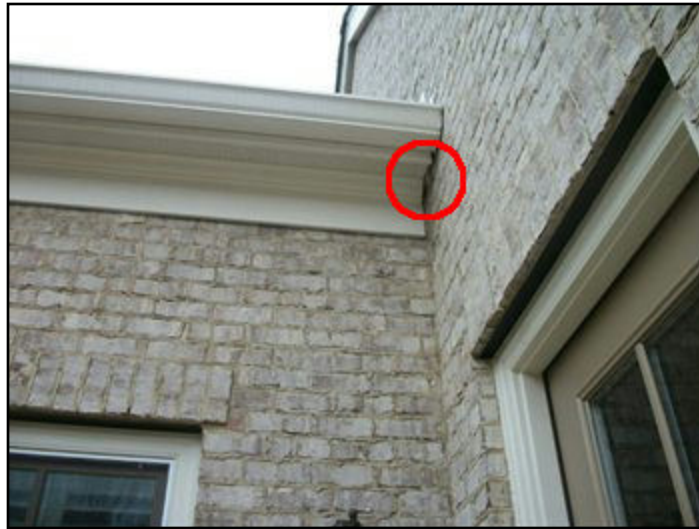
Condition: • [Loose or missing pieces](#)

A small opening in the eave located left of the rear pedestrian door should be repaired.

Implication(s): Cosmetic defects | Chance of water damage to contents, finishes and/or structure | Chance of pests entering house

15. Gap in soffit

Task: Repair

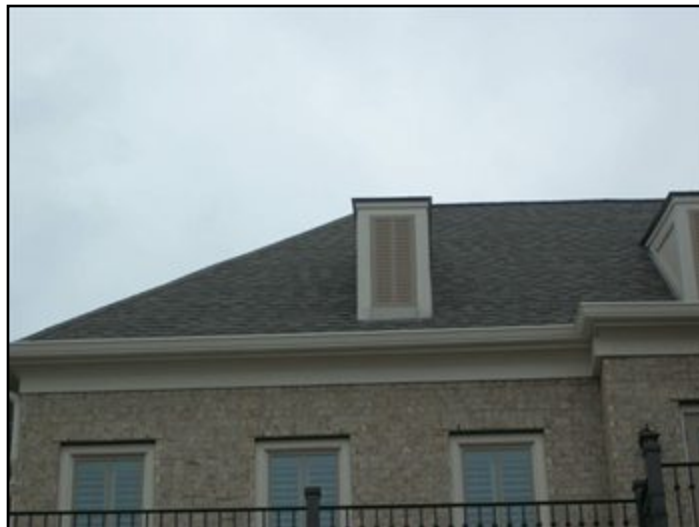
Condition: • [Paint](#)

Implication(s): Cosmetic defects | Shortened life expectancy of material

16. Trim needs painting

Task: Repair

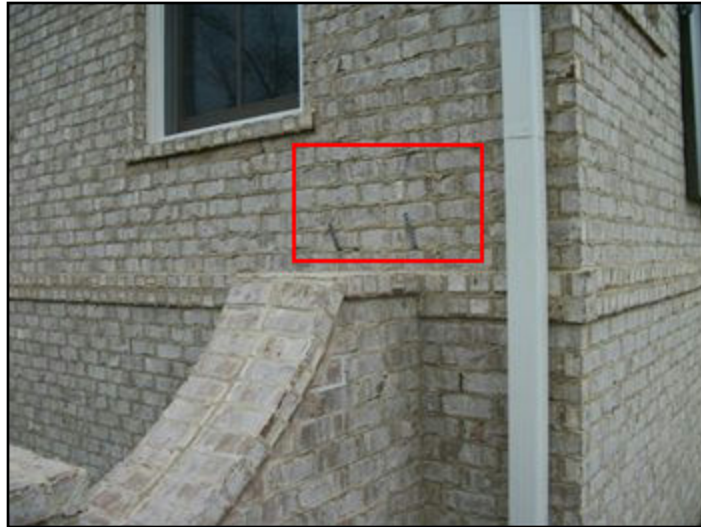
Condition: • Three brick ties are protruding from the wall above the wing wall.

17. Brick ties

Task: Remove

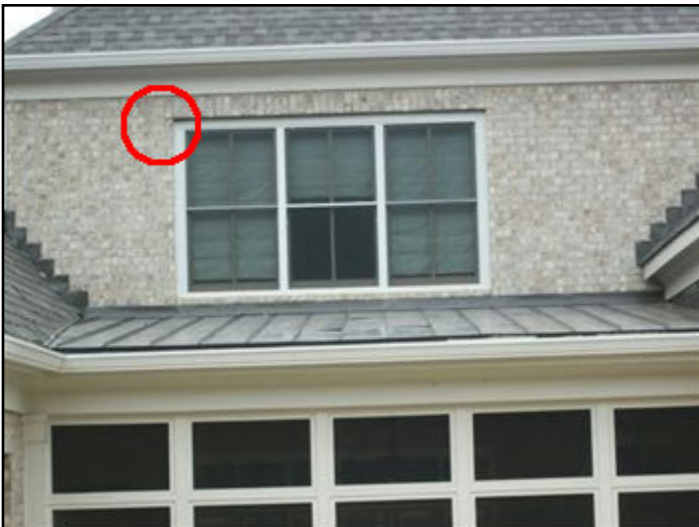
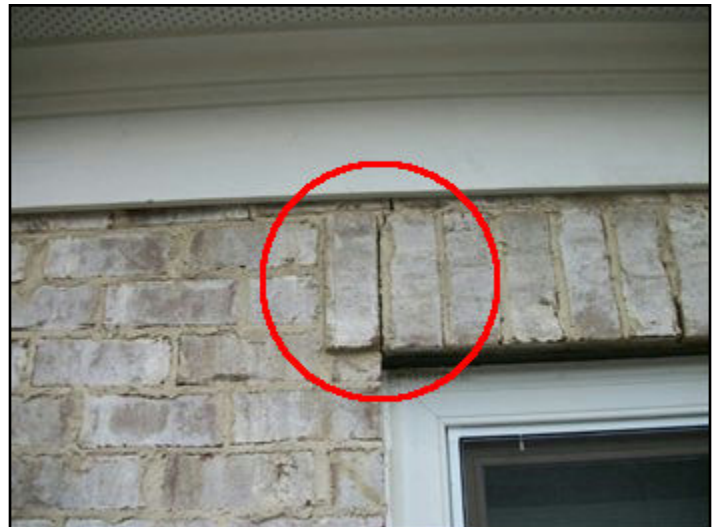
Condition: • A small crack was noted in a mortar joint above the left window.

19. Crack in mortar joint

Task: Repair/tuck-point joint

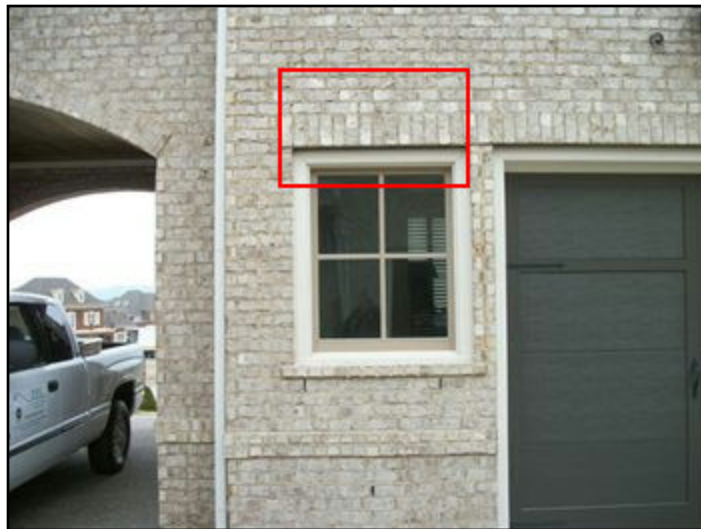
Condition: • [Missing, ineffective weep holes or flashings](#)

Implication(s): Chance of water damage to contents, finishes and/or structure | Material deterioration

20. Missing weep holes

Task: Repair

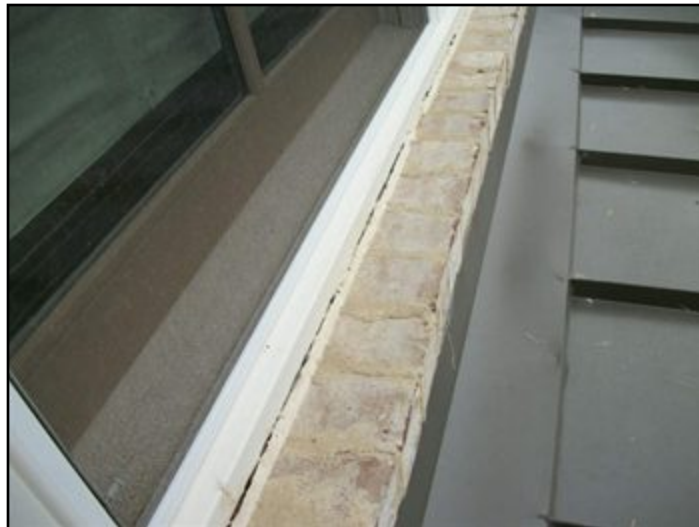
Condition: • [Caulking loose, missing or deteriorated](#)

Gaps are noted in the caulking on the bonus room windows.

Implication(s): Chance of water damage to contents, finishes and/or structure | Increased heating and cooling costs

21. *Gaps in caulking*

Task: Re-caulk where needed

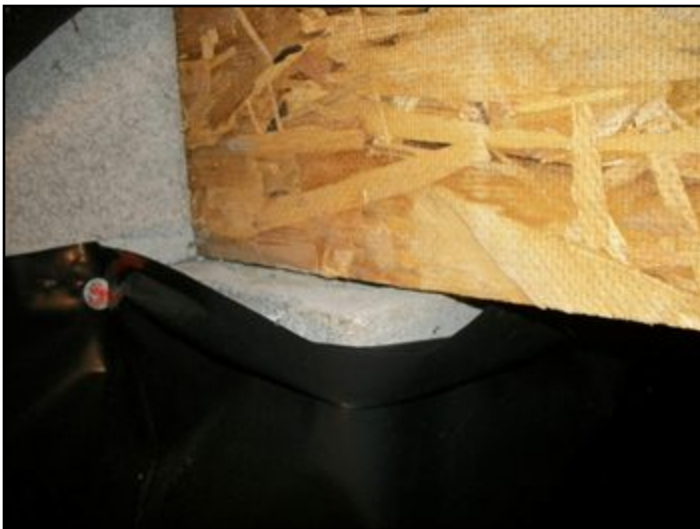
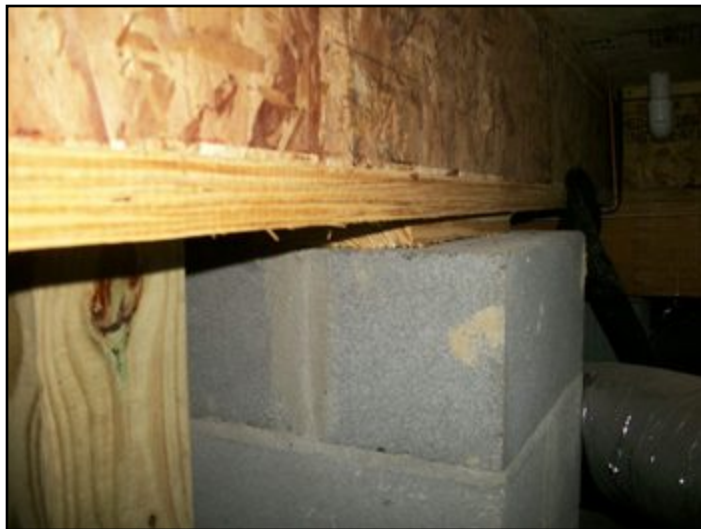
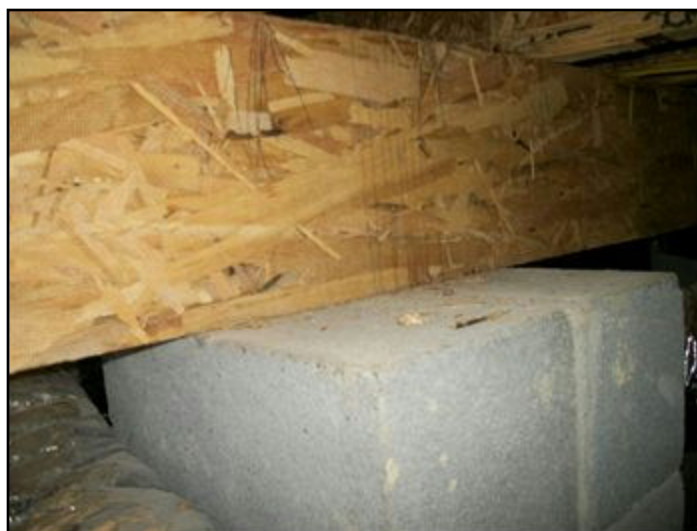
22. Missing vapor barrier

23. Missing vapor barrier

24. Missing vapor barrier

Task: Repair

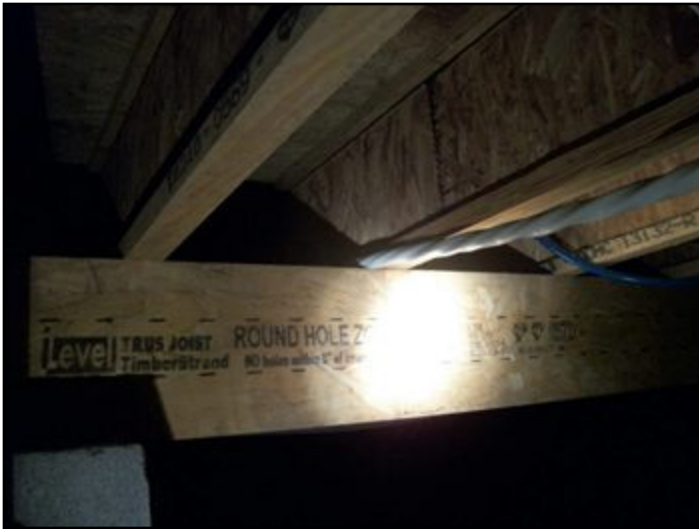
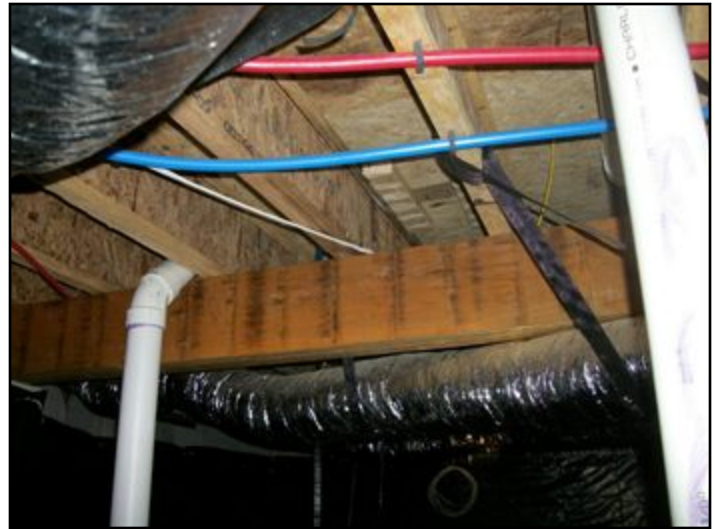
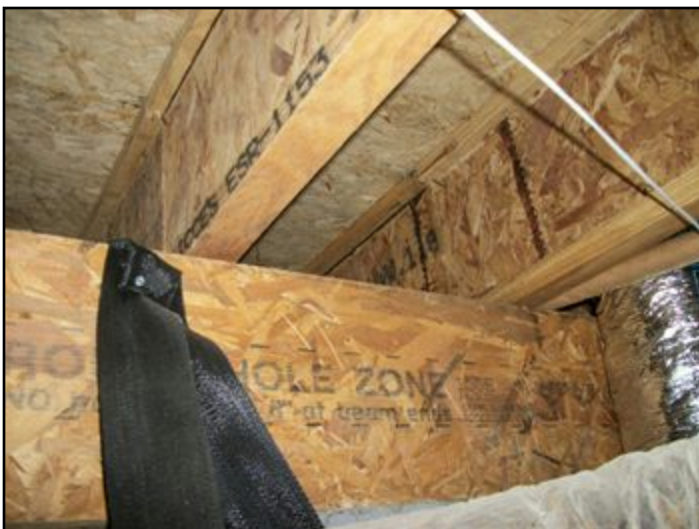
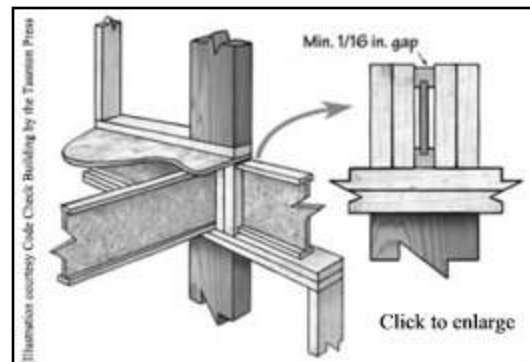
Condition: • [No blocking, bracing or bridging](#)

25. Missing blocking

27. Missing blocking

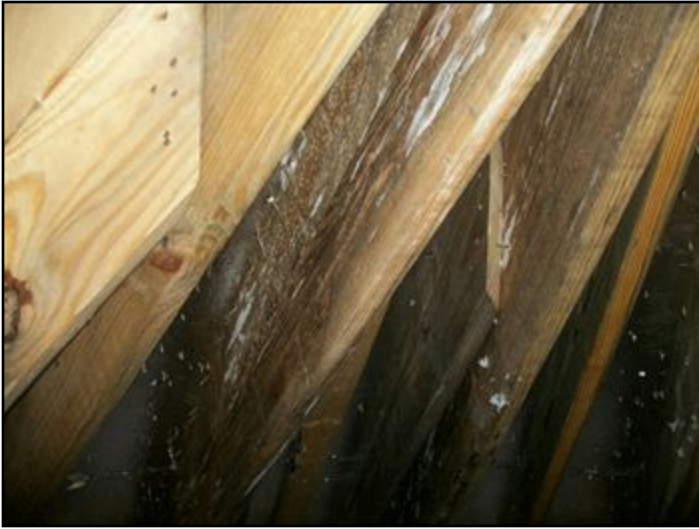
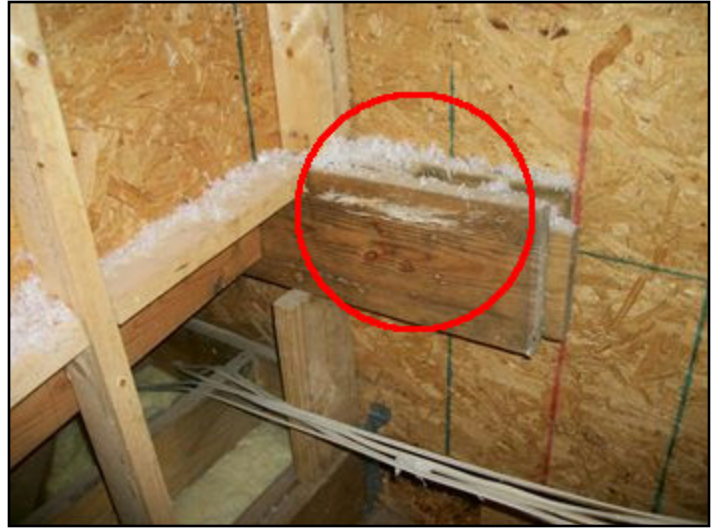
29. Mold-like substance

30. Mold-like substance

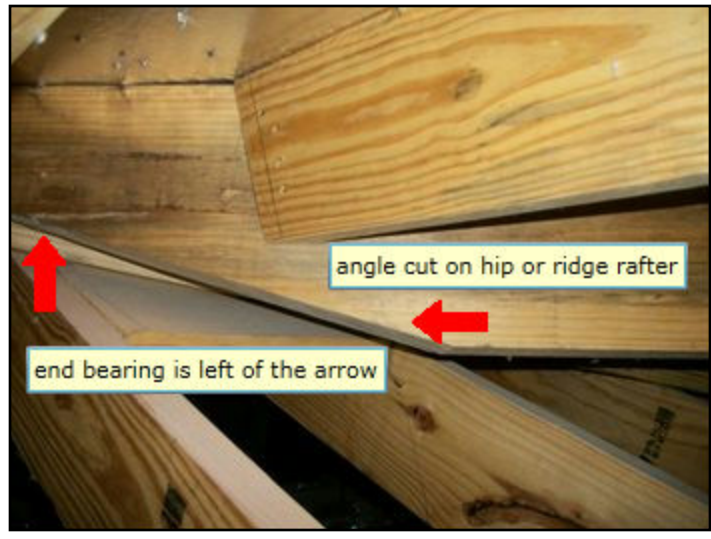
Condition: • [End bearing inadequate](#)

Task: Further evaluation

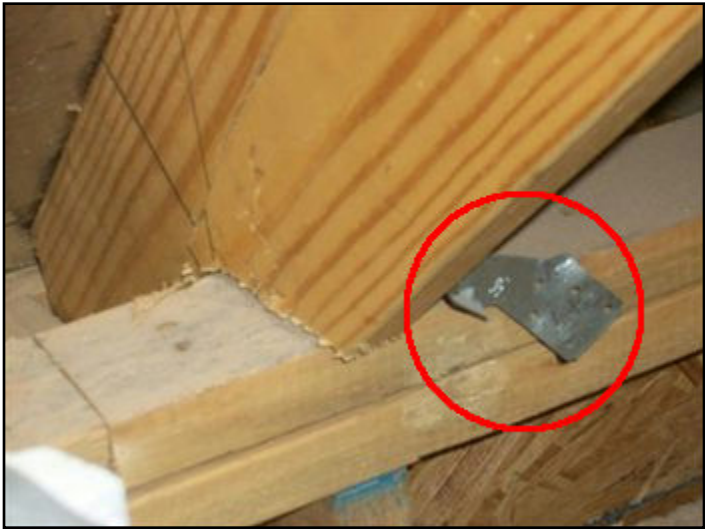
32. Loose tie-down bracket

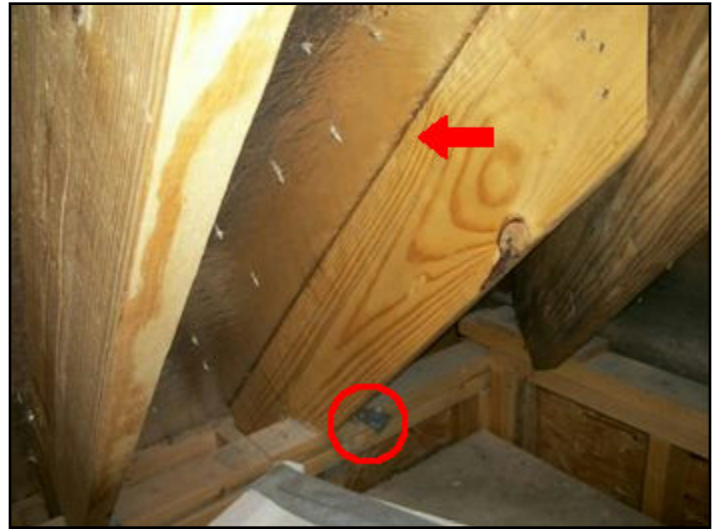
Condition: • [Split](#)

33. Cracked rafter

Task: Repair or replace

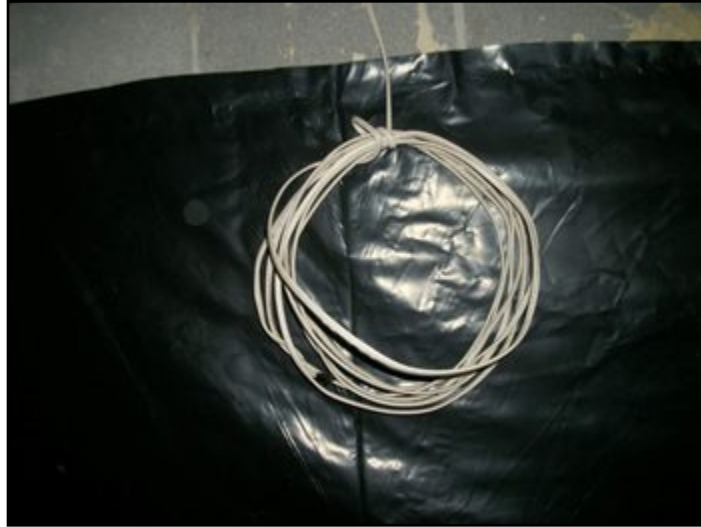
34. *Wire not properly terminated*

Task: Repair

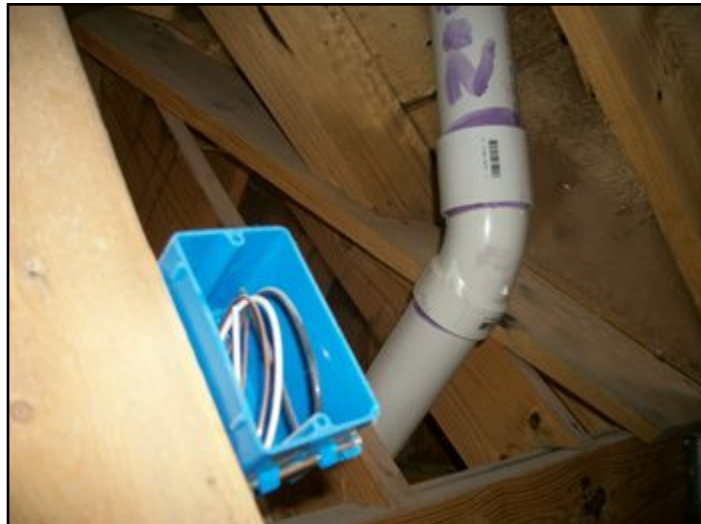
35. *Wires not properly terminated*

Task: Repair

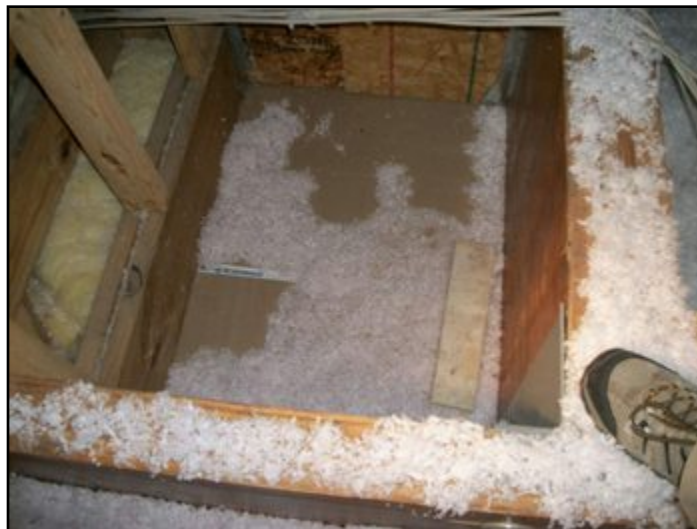
36. Missing insulation

Task: Repair

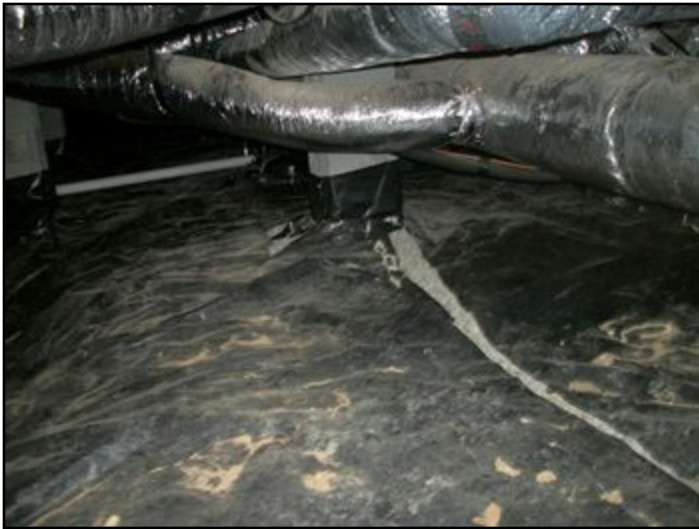
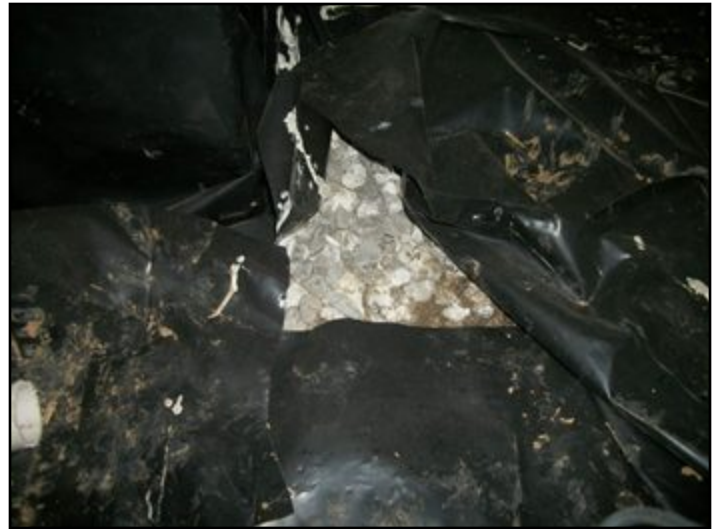
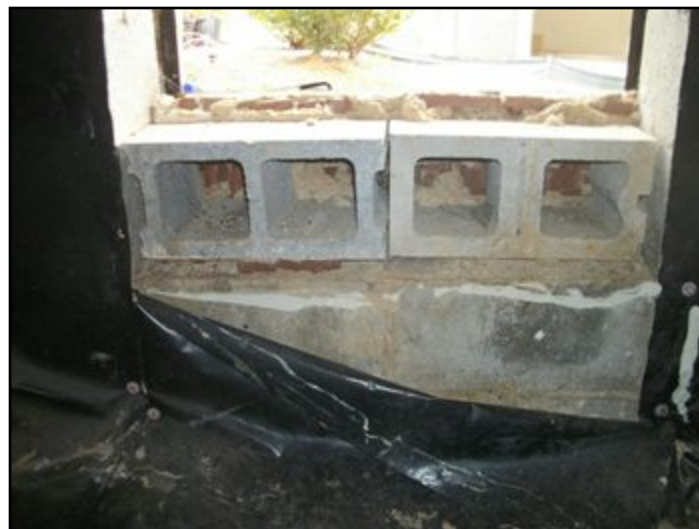
37. Gaps in vapor barrier

38. Gap in vapor barrier

39. Vapor barrier pulled loose from wall

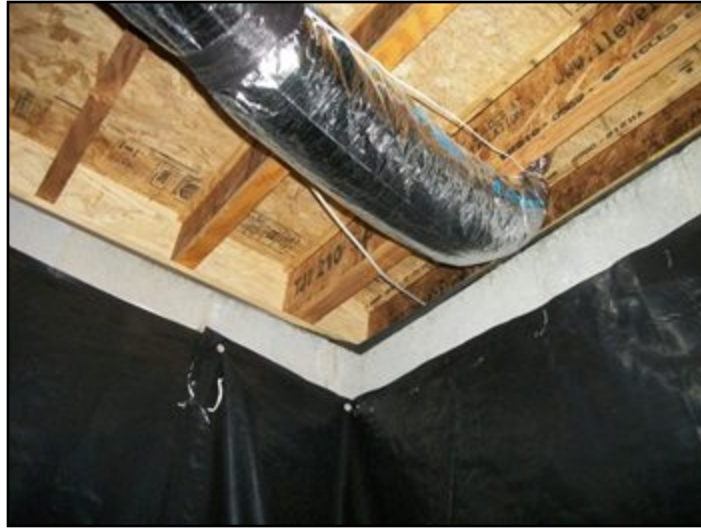
40. Missing rim insulation

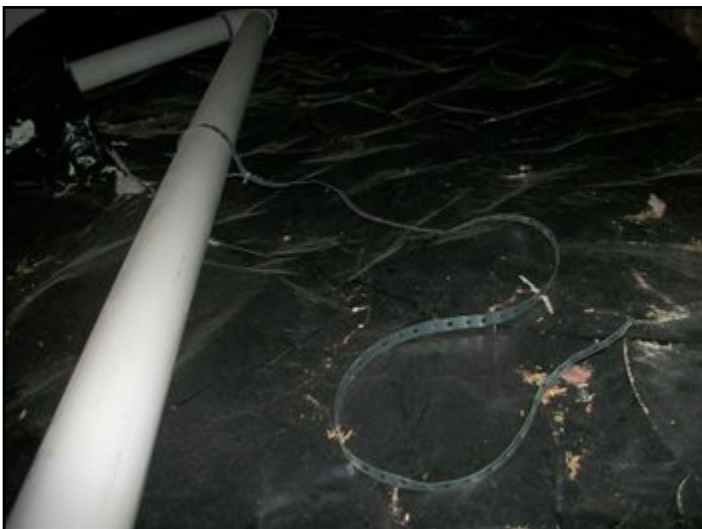
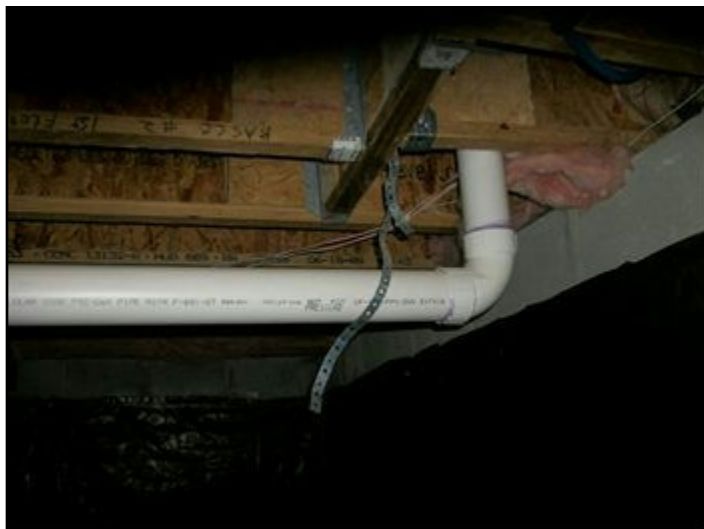
41. Loose strap

42. Loose strap

Task: Repair/secure

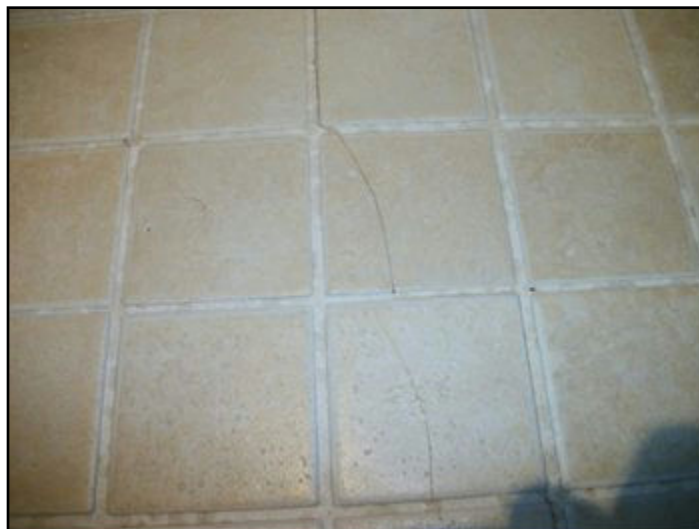
43. Cracked tiles

Task: Repair

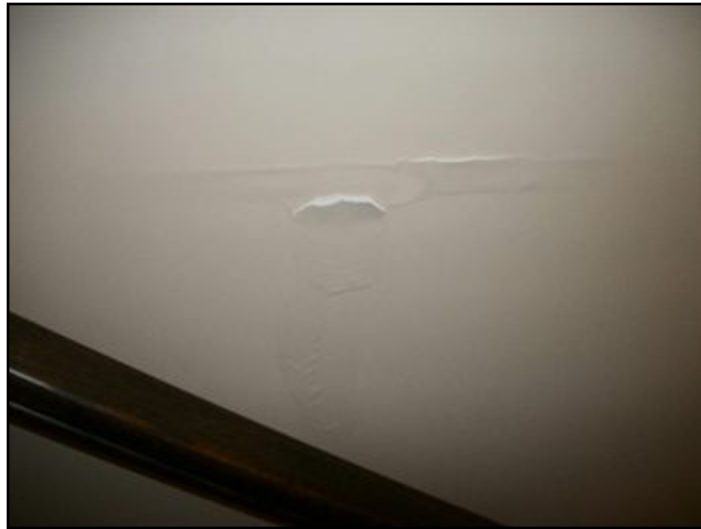
44. Possible water damage

Task: Further evaluation to determine cause and/or source of moisture.

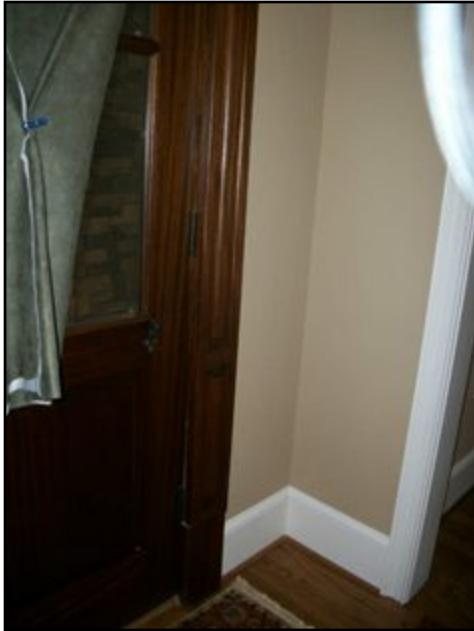
45. Gaps in trim

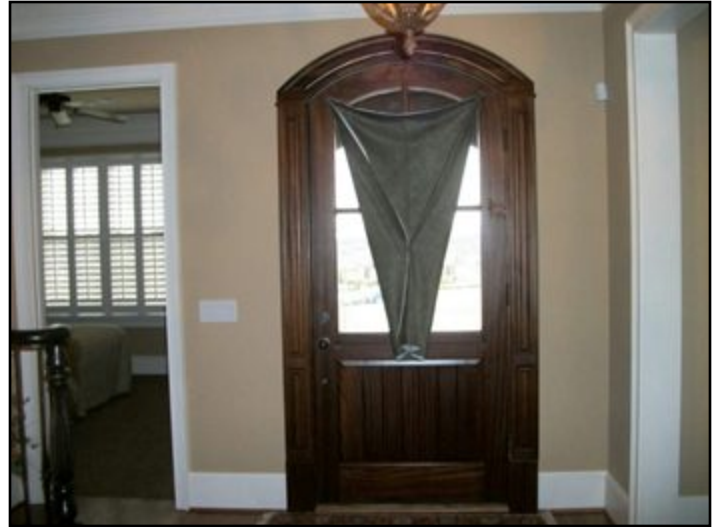
46. Front door facing west
